LANDSLIDE MANAGEMENT ON THE ISLE OF WIGHT

*Isle of Wight Centre for the Coastal Environment,
Isle of Wight Council, UK*

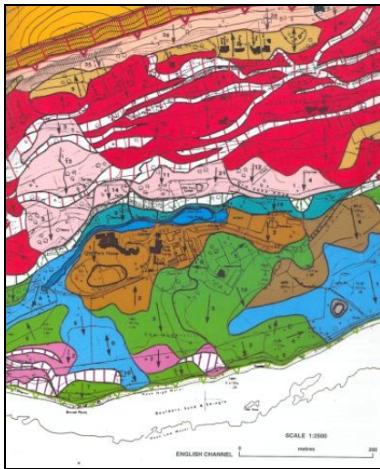
An example of the geomorphological maps held in the Coastal Centre

The Coastal Visitor's Centre in Ventnor holds copies of a series of geomorphological maps that were produced for the Council in 1991. These detailed 1:2500 scale maps cover the Undercliff from St Lawrence to Luccombe, and are a valuable source of information on ground behaviour, geomorphology and planning guidance. The maps are available to the public, and are used to assist potential homeowners and investors in making informed decisions about the purchase of properties on the Undercliff.

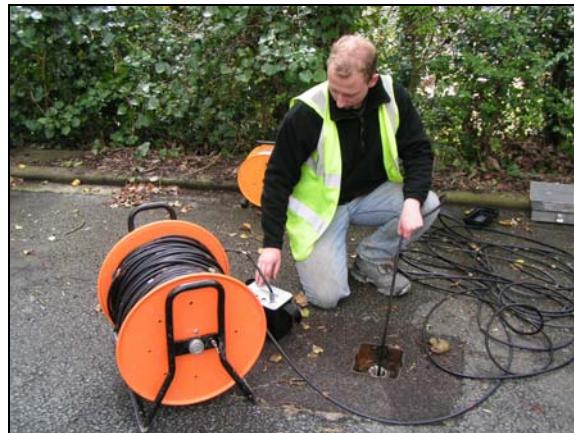
Surveying an instrumented site on the Undercliff Drive

The Council maintains an extensive network of sensors that monitor ground movement at various locations throughout the Undercliff, as well as one site at Afton Down. In addition, two automated weather stations provide valuable rainfall data that can be used to evaluate ground water conditions; an important causal factor in ground instability. The network currently comprises approximately 120 sensors, as well as several tell-tales to measure movement across cracks in areas where the installation of electronic sensors is not appropriate. New sensors are periodically added into the monitoring network if a need for greater sensor coverage is identified and the resources are available.
